Unplanned Interruptions Report

for the assessment period ended 31 March 2023

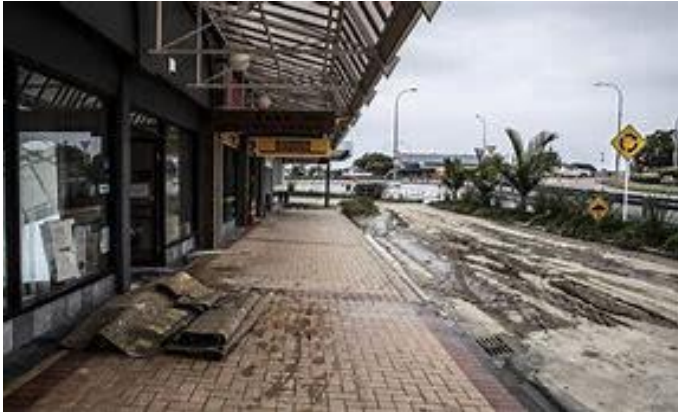
Photograph 6: Main street of Wairoa township

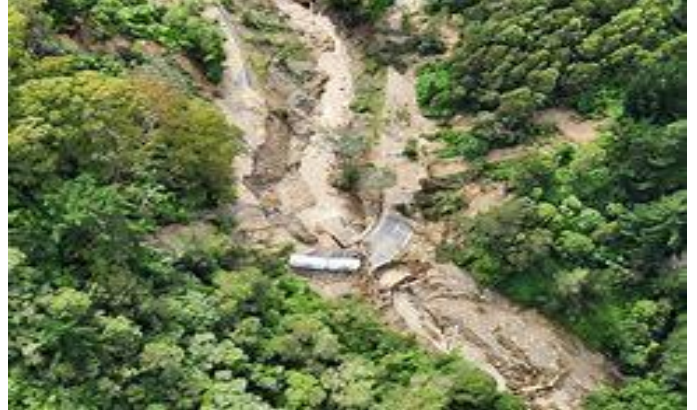
Photograph 7: Roading impacted in Tairāwhiti

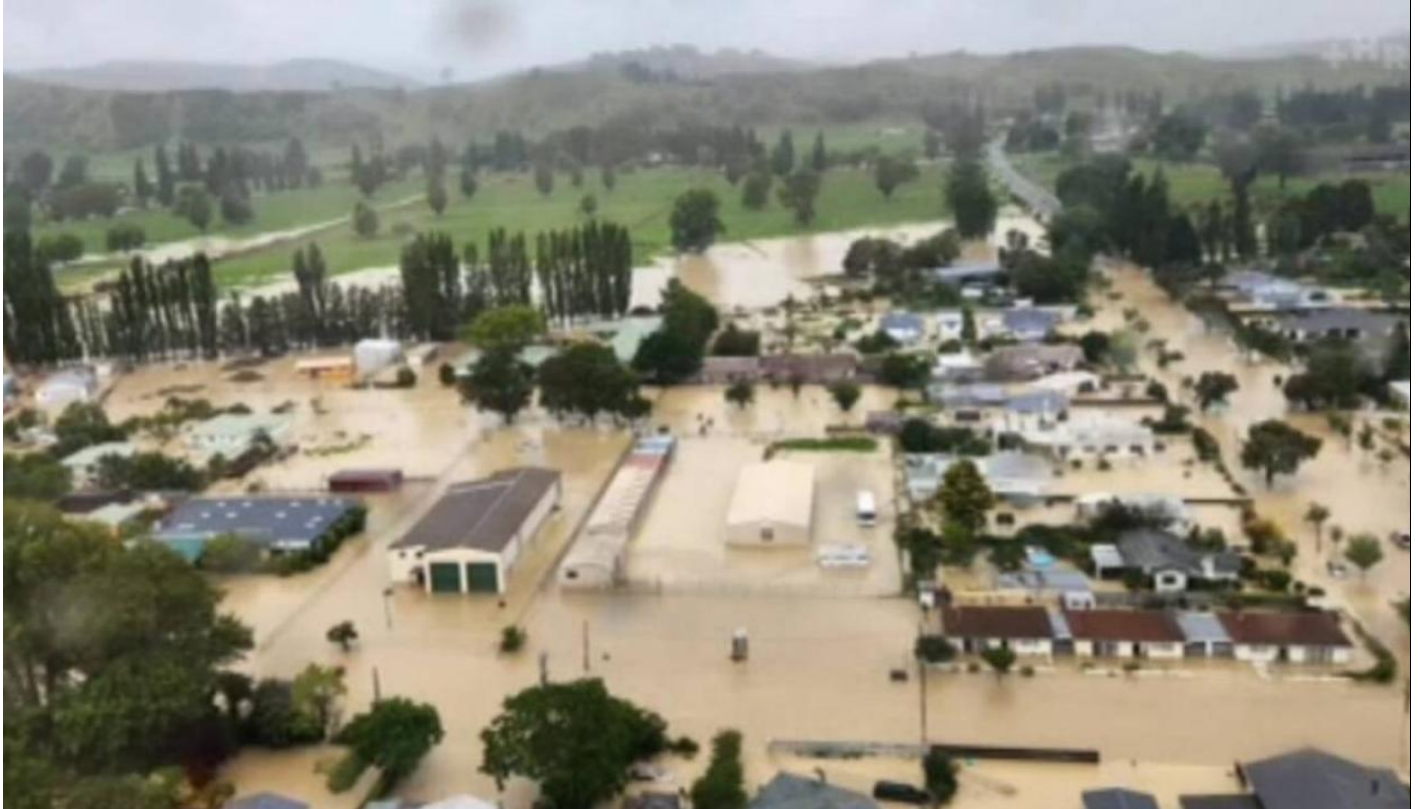
Photograph 8: The town of Wairoa is completely cut off by flood waters

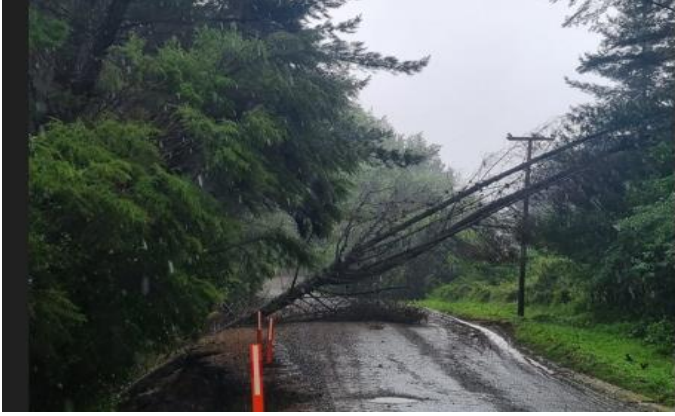
Photograph 1: line damage caused by trees outside the fall zone going through lines in April 2022

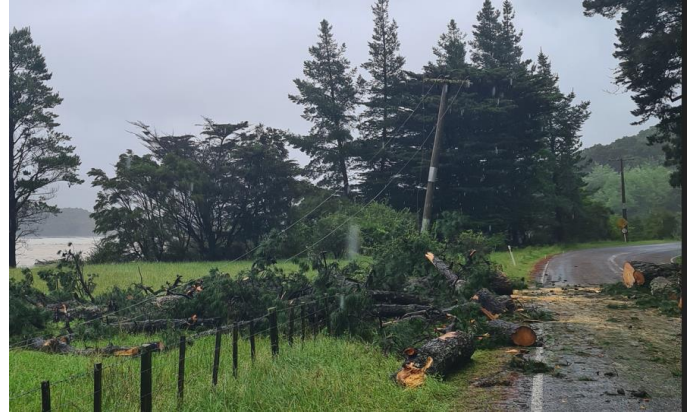
Photograph 2: line damage caused by forestry trees outside the fall zone in June 2022

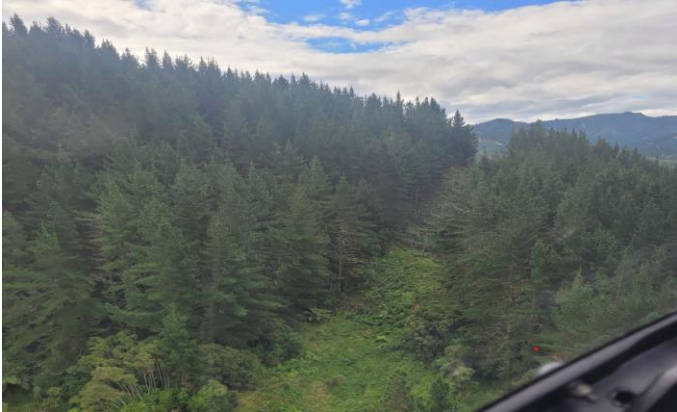
Photograph 3: lines damaged running through the Tuangaheru Mata forest in July 2022

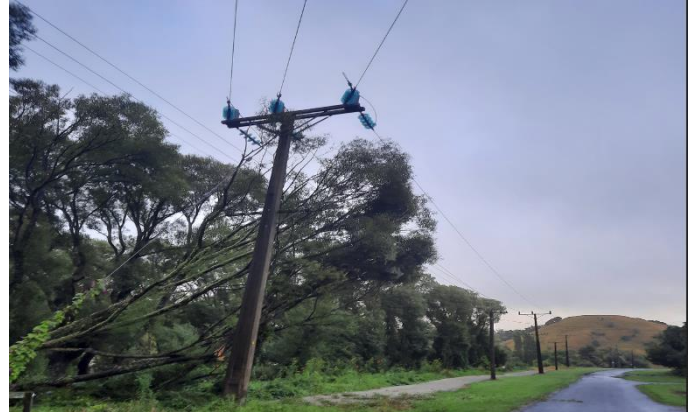
Photograph 4: Line damage in Tiniroto caused by trees outside the fall zone in November 2022

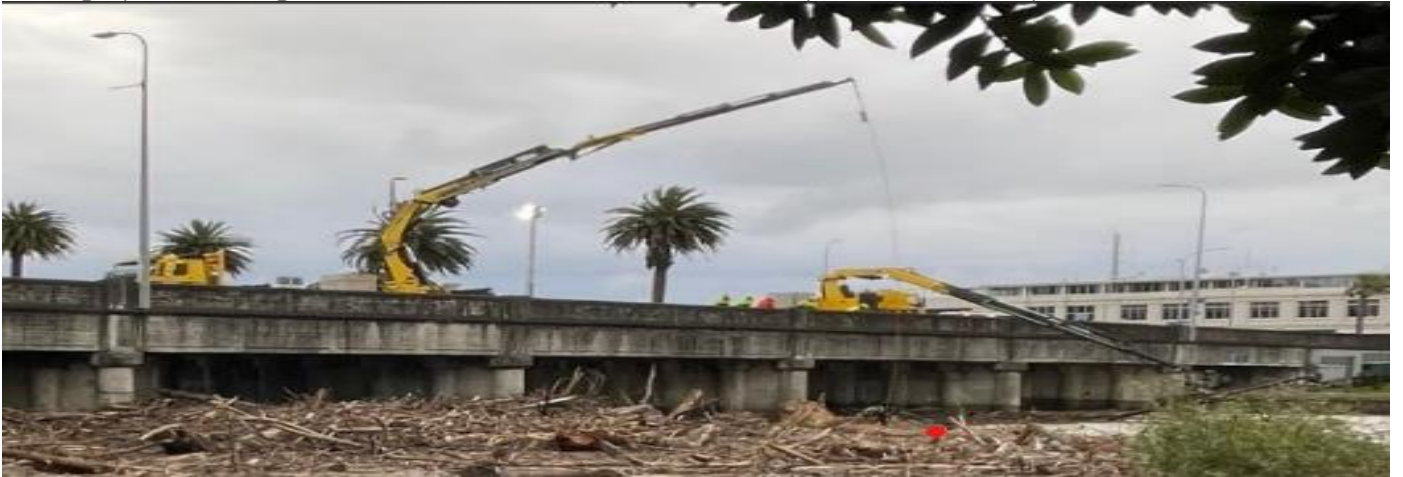
Photograph 5: damage to infrastructure in Tairāwhiti caused by floods in January 2022

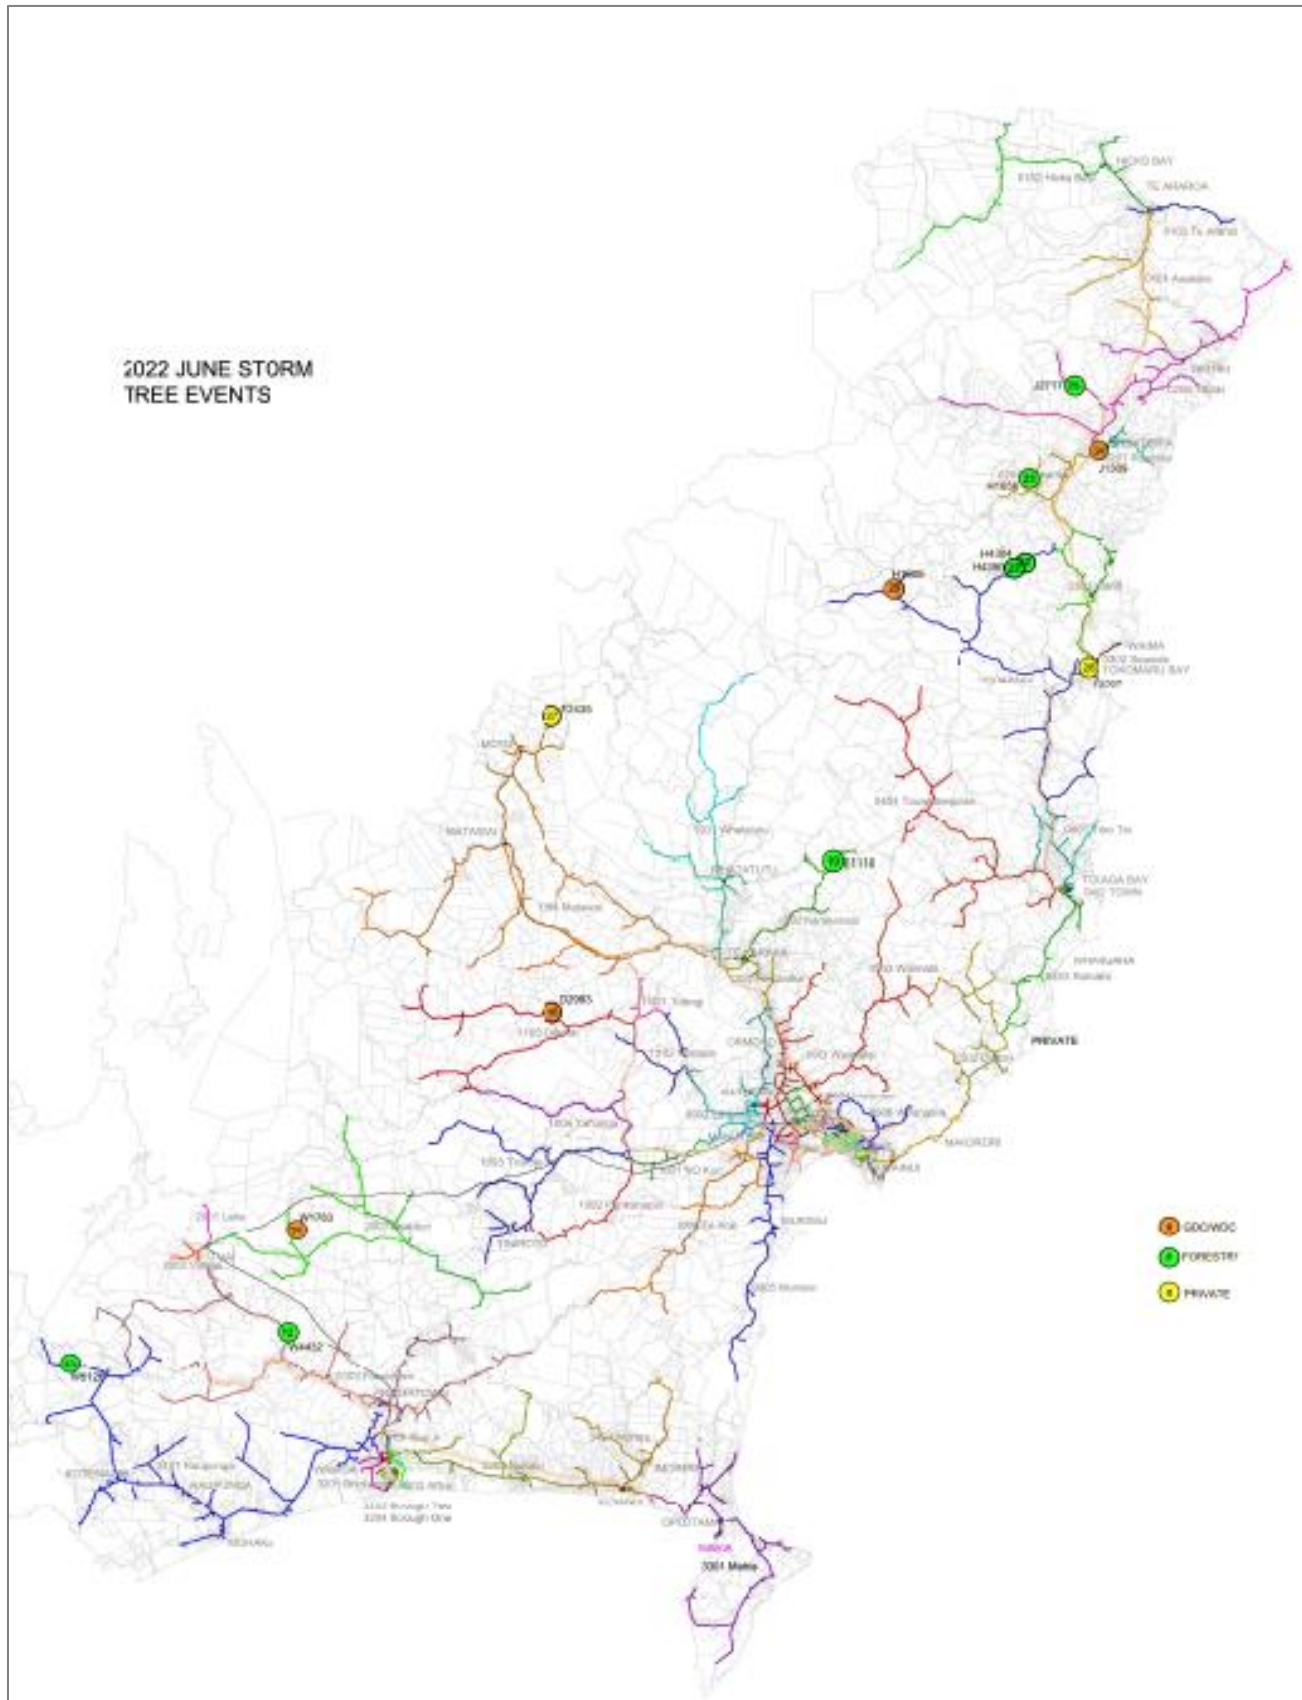
Figure 2: Tree Fault Map June 2023

Figure 2 to Figure 4 are maps of the damage to our network caused by trees in June, July, and January. The maps illustrate that tree damage during the period was sporadic and widespread. Vegetation management and tree ownership do not appear to contribute to tree damage. The maps show a mix of council, forestry, and privately owned trees caused damage to the network. Our records show that the areas were part of our vegetation management programme, and the trees causing the damage were outside the regulated notice and growth limit zone.

Damage to our lines during the assessment year was not from trees within the notice or growth limit zone. Rather the extreme weather conditions resulted in out-of-zone trees being thrown into our lines, causing extensive damage. The regulations give us no power to manage vegetation outside the notice zone, leaving us vulnerable to outages caused by out-of-zone trees.

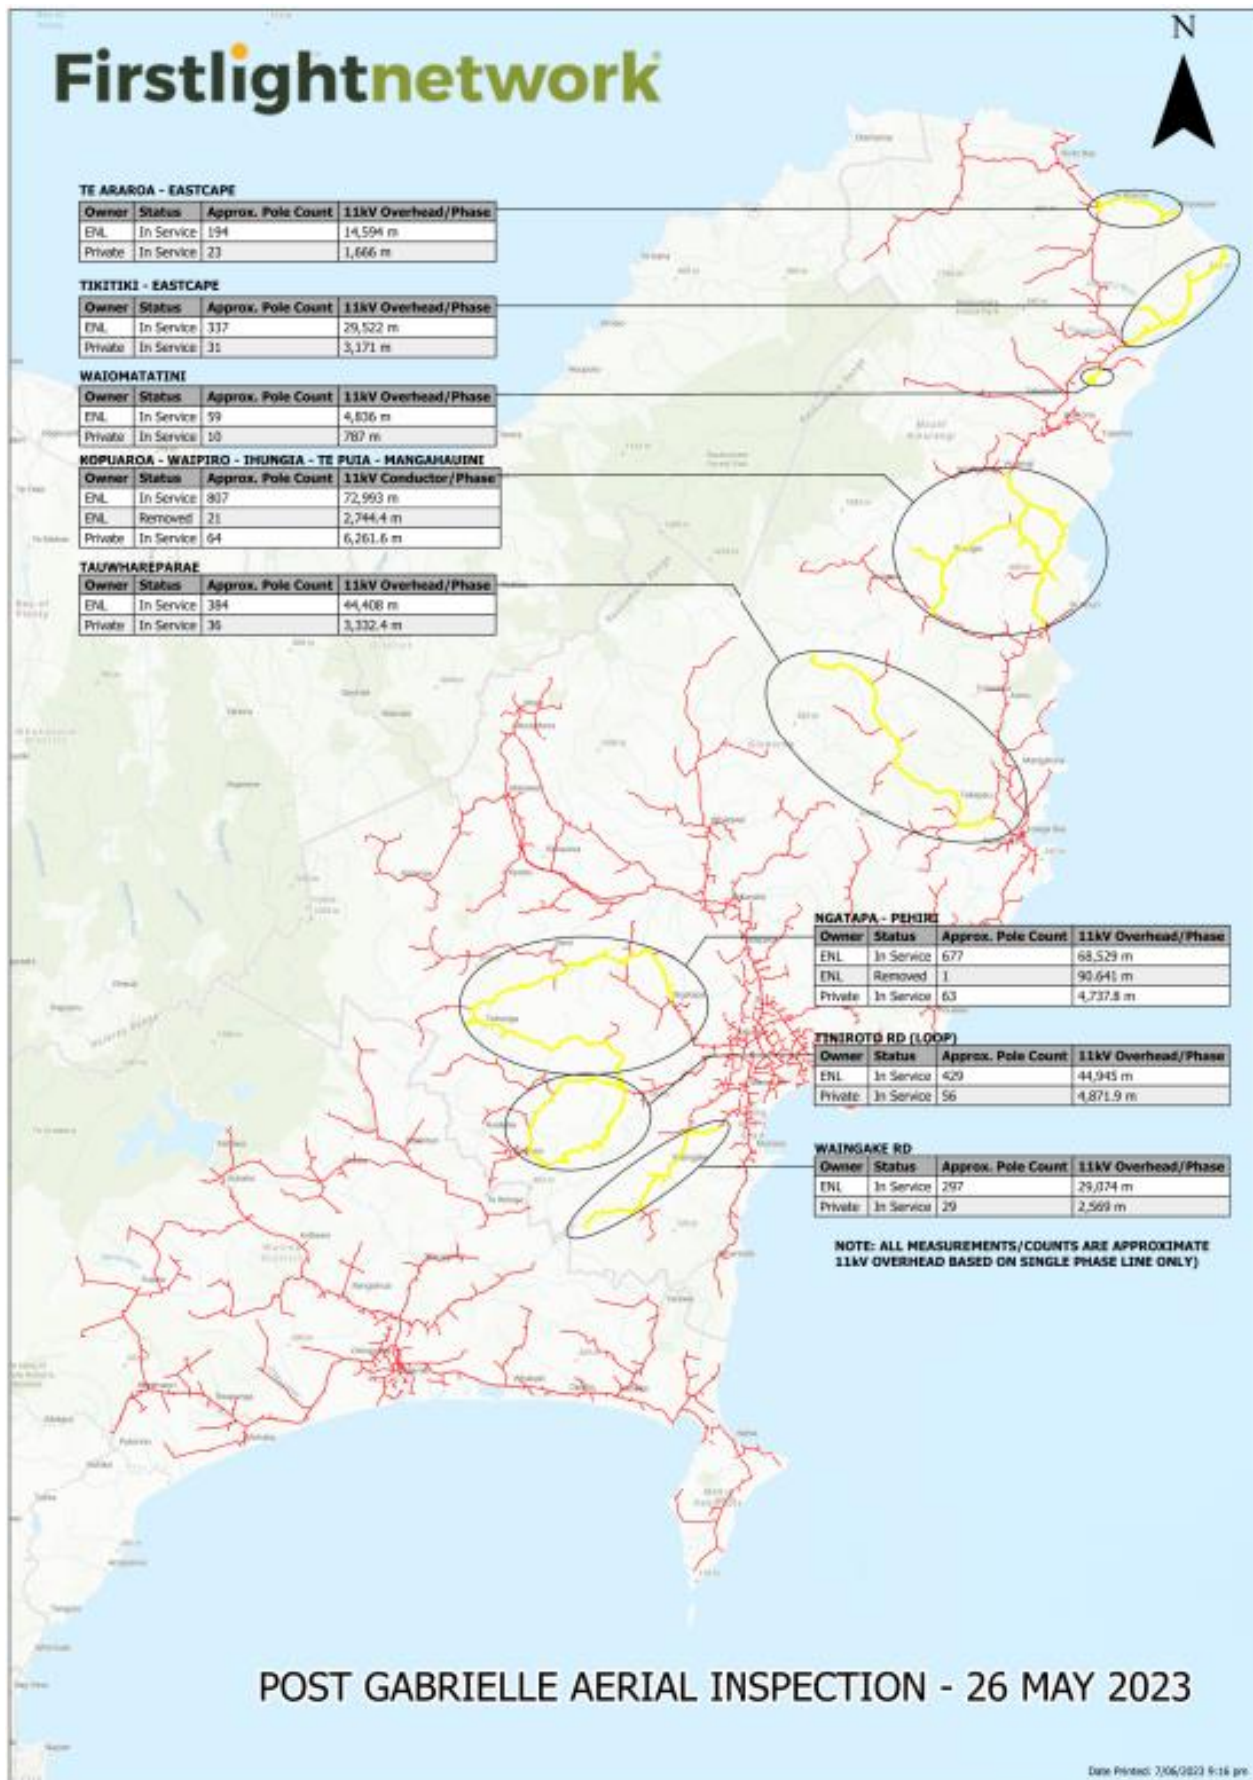
Figure 5: Post-Gabrielle Aerial Inspection

Figure 5). We inspected a sample of feeders and assessed the damage, e.g., slips near poles, leaning poles, and trees that had an increased probability of contacting our lines (i.e., trees made unstable by high winds that were at an increased risk of falling into our lines post the event).

- 2,165 poles, marked 174 for replacement and 176 for remedial maintenance, as
- 536 transformers, earth tested 564, and found 317 defects, as shown.

In the weeks following Cyclone Gabrielle, we combined the information collected via the flyover and ground observations. We updated our routine maintenance programs to reflect the state of our network post-Cyclone Gabrielle. We identified 11 issues arising from Cyclone Gabrielle that needed immediate attention, remained we rolled into our routine maintenance program. We inspected 13% of our distribution lines (i.e., 309 km of our 2,388 km 11kv conductor) and 12% of our poles (i.e., 3181 of our 25,485 11kv poles). We have included a summary of the results in Table 3.

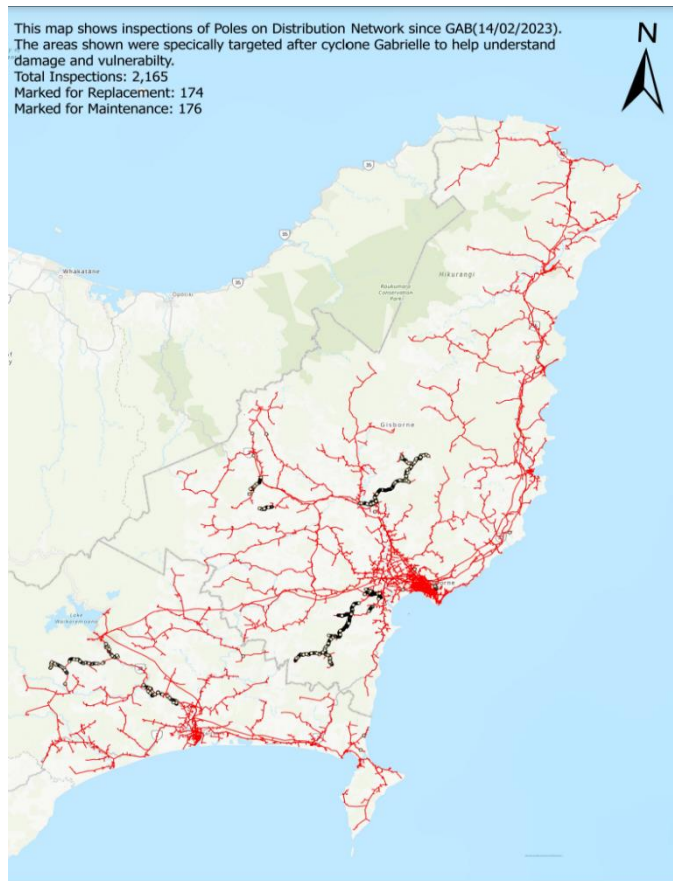
Figure 6: Map showing pole inspections arising from ariel review following Cyclone Gabrielle

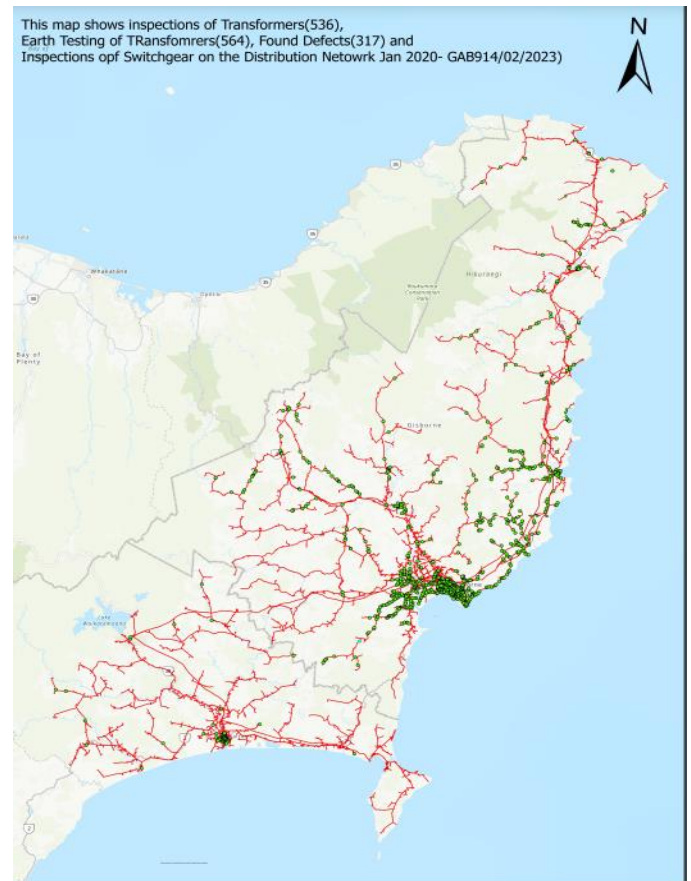
Figure 7: Map showing transformer inspections arising from ariel review following Cyclone Gabrielle
