Unplanned Interruptions Report

for the assessment period ended 31 March 2023

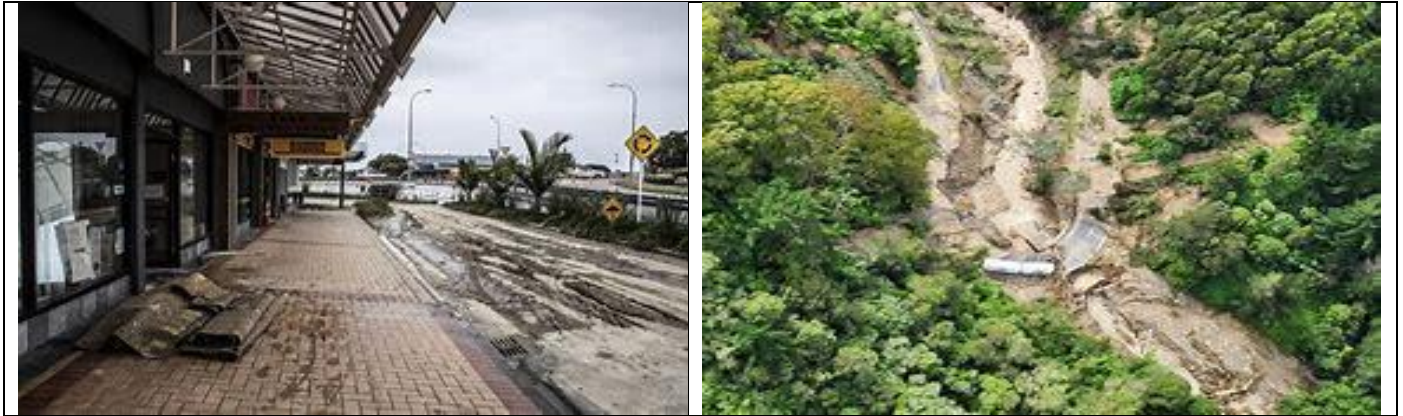
Photograph 7: Roading impacted in Tairawhiti

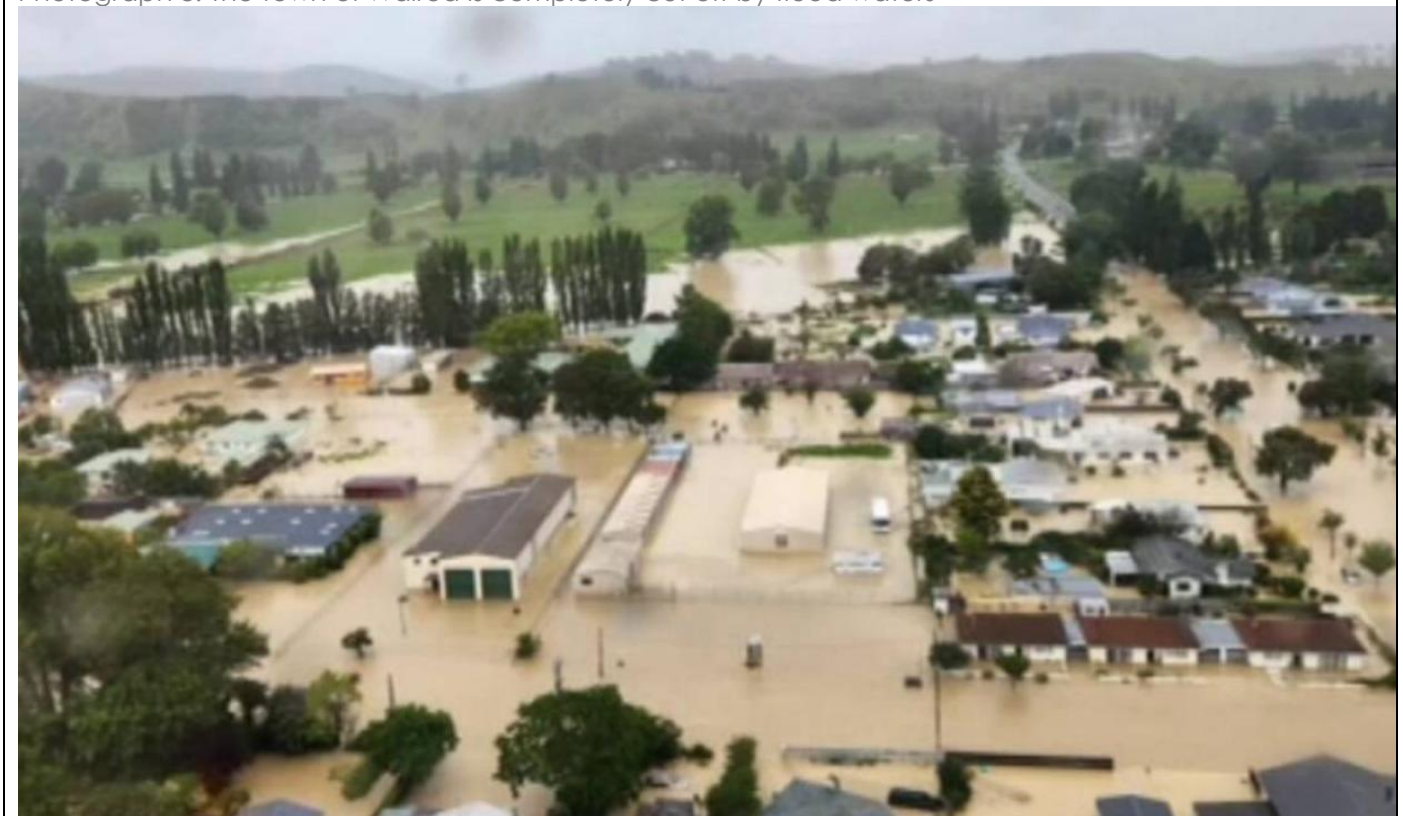
Photograph 8: The town of Wairoa is completely cut off by flood waters

Flood waters breached stopbanks across Hawke's Bay, caused partly by the buildup of forestry slash at bridges. There were over thirty stop bank breaches covering some five kilometres.⁸ Power was lost to our entire network (i.e., all 26,000 ICPs) when the transmission network was extensively damaged; of those ICPs, 4,500 were impacted due to damage to our distribution network. Roading was widely impacted, with 19 bridges washed away and many unsafe crossings.

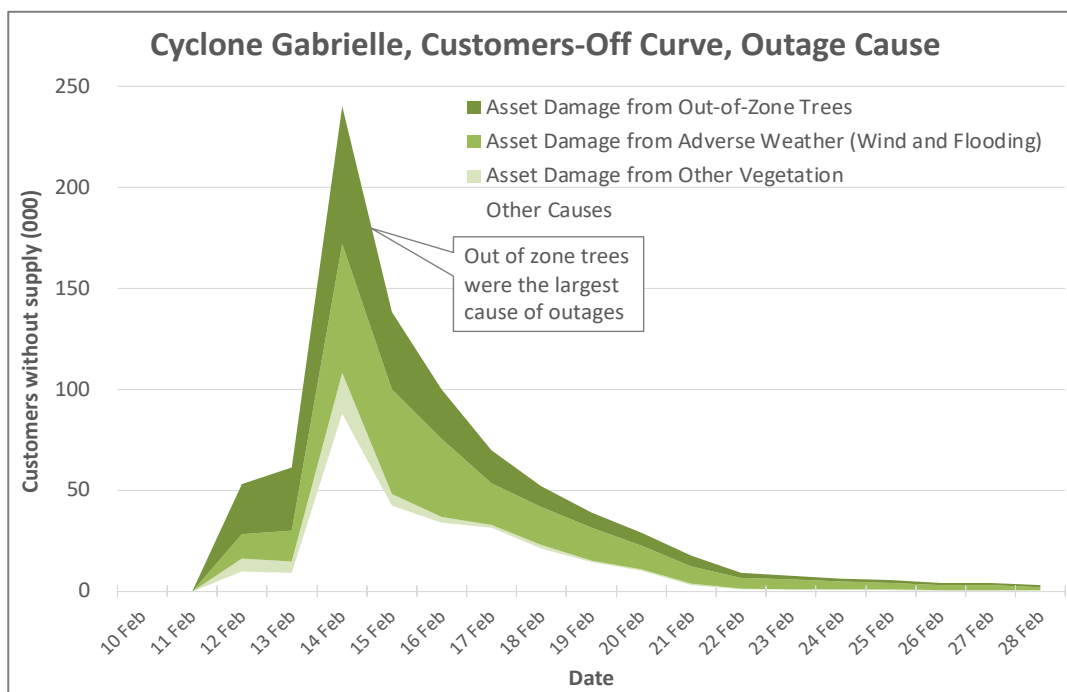
Figure 8: Material causes of customer outages extract from the energia report¹⁴

Energia determined that the largest cause of outages for EDBs was out-of-zone tree damage, and the second largest cause was high winds causing damage to overhead lines, followed by flooding damaging assets (including substations), as shown in Figure 8.¹³

Trees pose a significant hazard to distribution assets; strong winds increase this risk by toppling trees and breaking branches. The Tree Regulations are intended to give EDBs mandated powers to address the risk from trees. However, as discussed in Sub-section 2.2.2 above, EDBs are not mandated to trim or remove trees outside the growth zone (i.e., out-of-zone trees). EDBs must negotiate with the tree owner to trim or remove trees at risk of damaging assets.

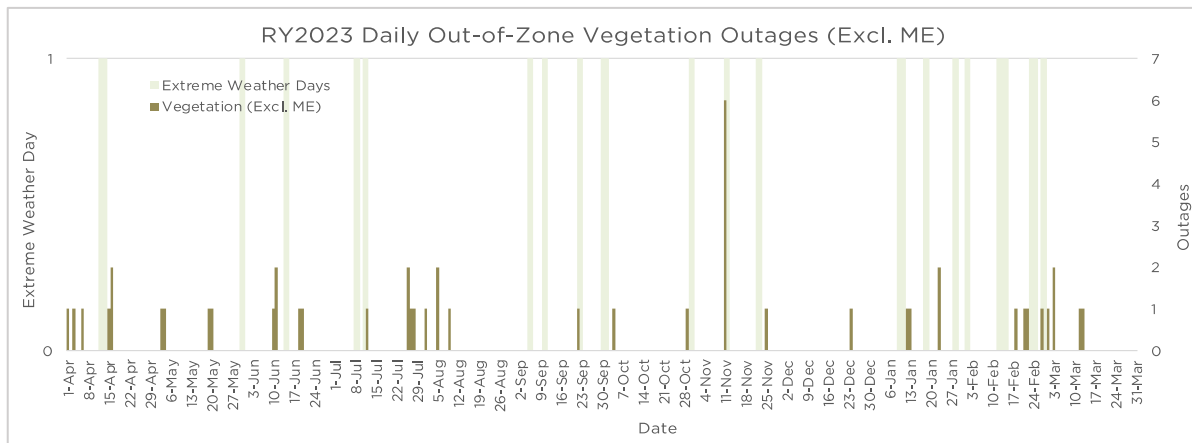
Figure 18: Out-of-zone tree contacts vs. Extreme Weather Days³⁹

The increase in out-of-zone tree contacts was weather related. As shown in Figure 18 and Figure 19, many out-of-zone tree contacts also correlated with the high rainfall and wind.³⁸

As shown in Figure 18 and Figure 19 above, we believe the weather conditions throughout the year were a key reason for the increase in out-of-zone tree outages. We consider the weather conditions abnormal and have normalised them in our counterfactual assessment.

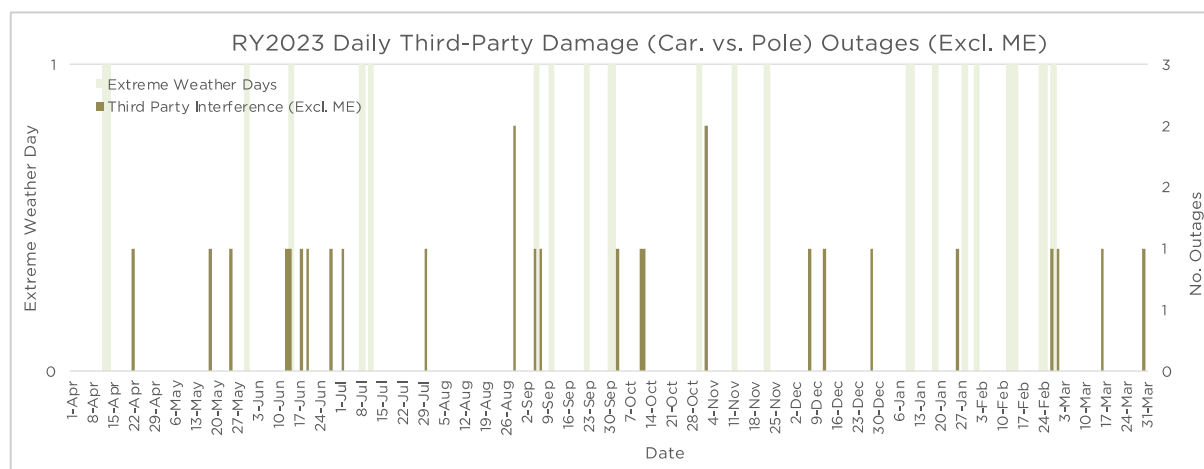
Figure 20: Vehicle Damage vs. Extreme Weather Days⁴⁶

The exact reason for the rise in vehicle damage to the network is difficult to determine. We suspect that the increase in extreme weather events and the significantly higher rainfall contributed to the increase.

As shown in Figure 20 above, we saw many vehicle damage incidents during extreme weather

As shown in Figure 20 and Figure 21 above, we believe the weather conditions throughout the year contributed to increased vehicle damage SAIDI. We consider the weather conditions abnormal and have normalised them in our counterfactual assessment.

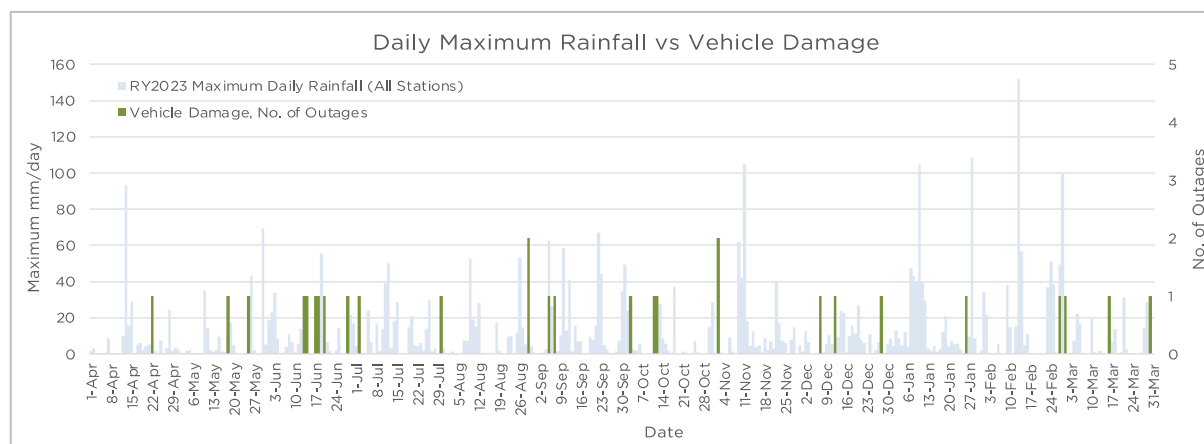
Figure 21: Vehicle Damage vs. Daily Rainfall⁴⁷

events. As shown in Figure 21 above, many vehicle incidents coincided with high rainfall and wind.
